**Loss of Pitch Control During Takeoff  
Air Midwest Flight 5481  
Raytheon (Beechcraft) 1900D, N233YV  
Charlotte, North Carolina  
January 8, 2003**

**Aircraft Accident Report**  
**NTSB/AAR-04/01**

**Air Midwest Flight 5481**

**Raytheon (Beechcraft) 1900D, N233YV**

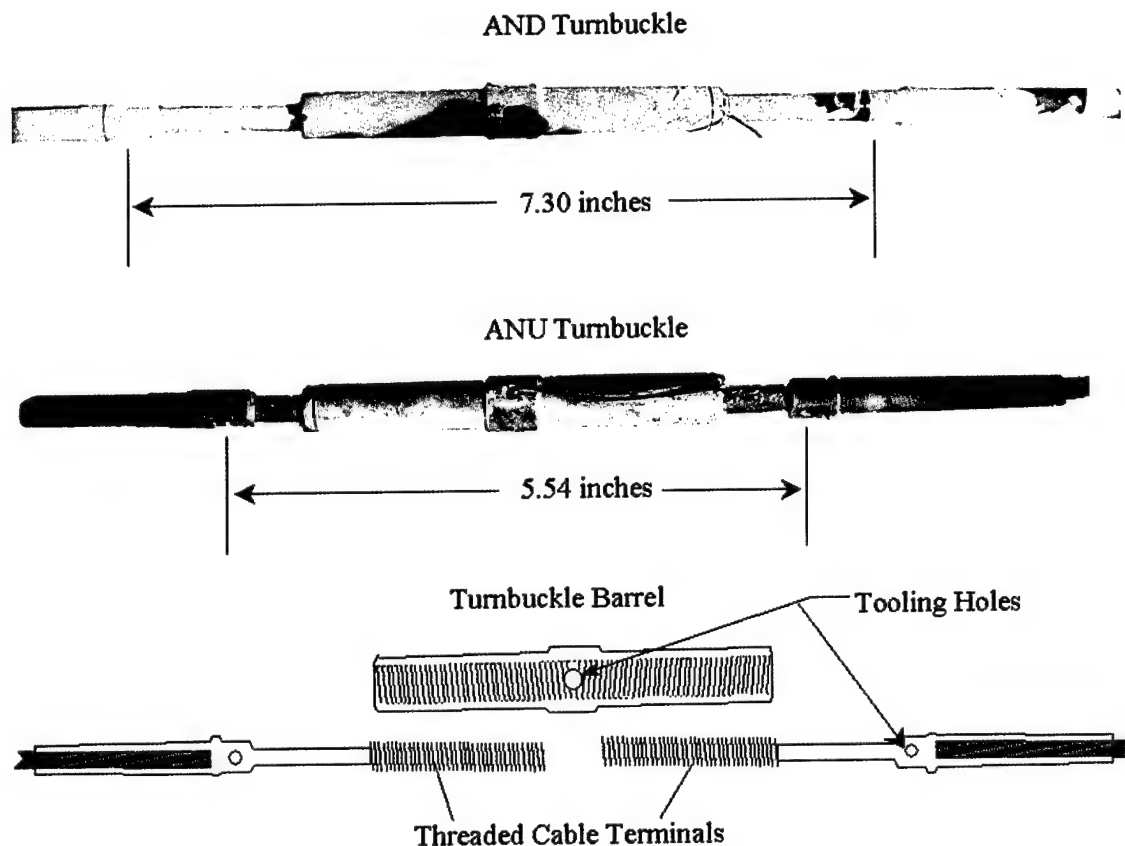
The ANU turnbuckle was almost fully contracted, and the AND turnbuckle was almost fully extended. The measurement from the center of the tooling hole in one threaded cable terminal to the center of the tooling hole in the other cable terminal was 5.54 inches for the ANU turnbuckle and 7.30 inches for the AND turnbuckle. In addition, the AND turnbuckle had one thread visible, and the ANU turnbuckle did not have any threads visible. Figure 6 shows the turnbuckles as found in the wreckage and a drawing that shows a turnbuckle barrel and threaded cable terminals.

**Figure 6.** Turnbuckles as found in the wreckage.

The AND turnbuckle was extended 1.76 inches more than the ANU turnbuckle. After the accident, Air Midwest surveyed its entire fleet of 42 Beech 1900D airplanes, which represented 25 percent of the 164 Beech 1900D airplanes active in the North American fleet. Air Midwest data submitted to the Safety Board indicated that, on average, the AND turnbuckle was extended 0.04 inch less than the ANU turnbuckle.

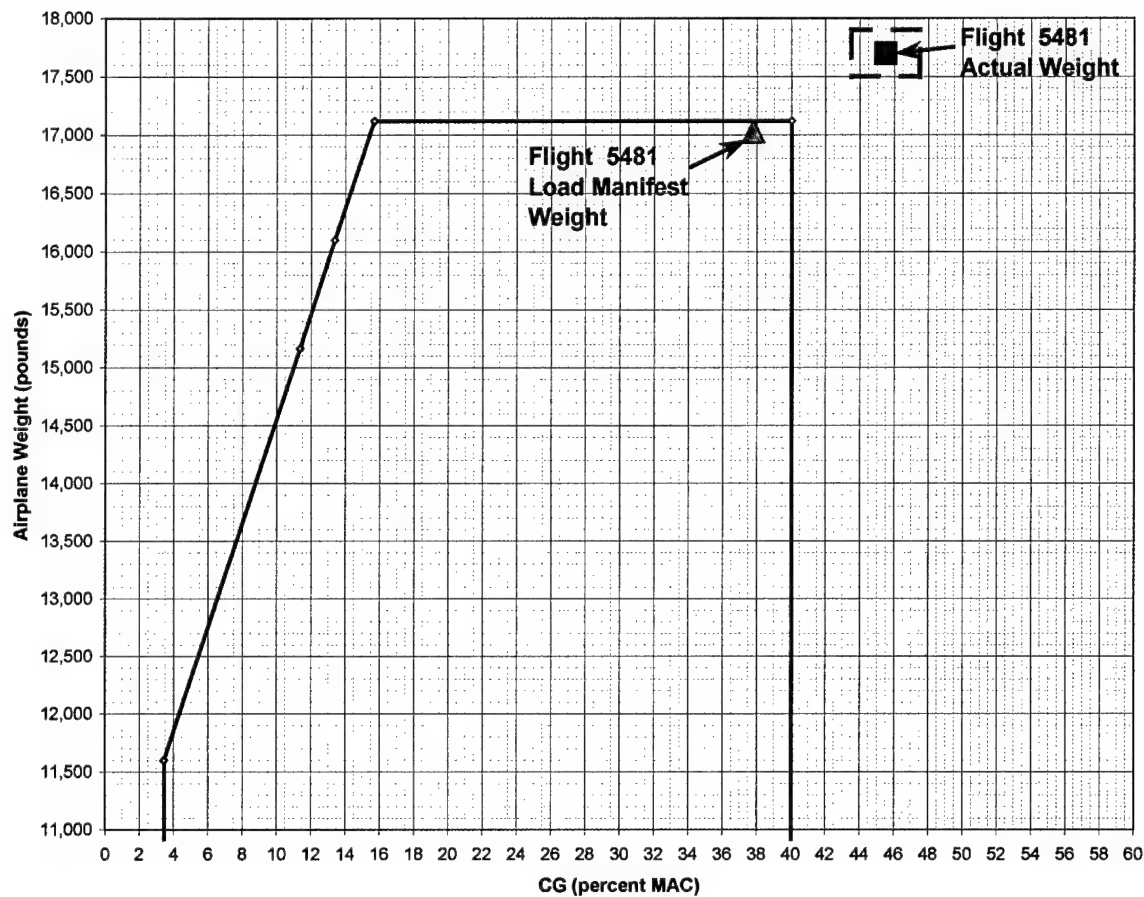
On the basis of these FDR data, radar data, the validated force and moment model, and component weight and location information, the Safety Board determined that the accident airplane had an actual weight of  $17,700 \pm 200$  pounds and an actual CG position of  $45.5 \pm 2$  percent MAC. Figure 7 shows the results of the Board's calculations overlaid on the Beech 1900D weight and CG envelope.

**Figure 7.** Weight and center of gravity information for flight 5481.

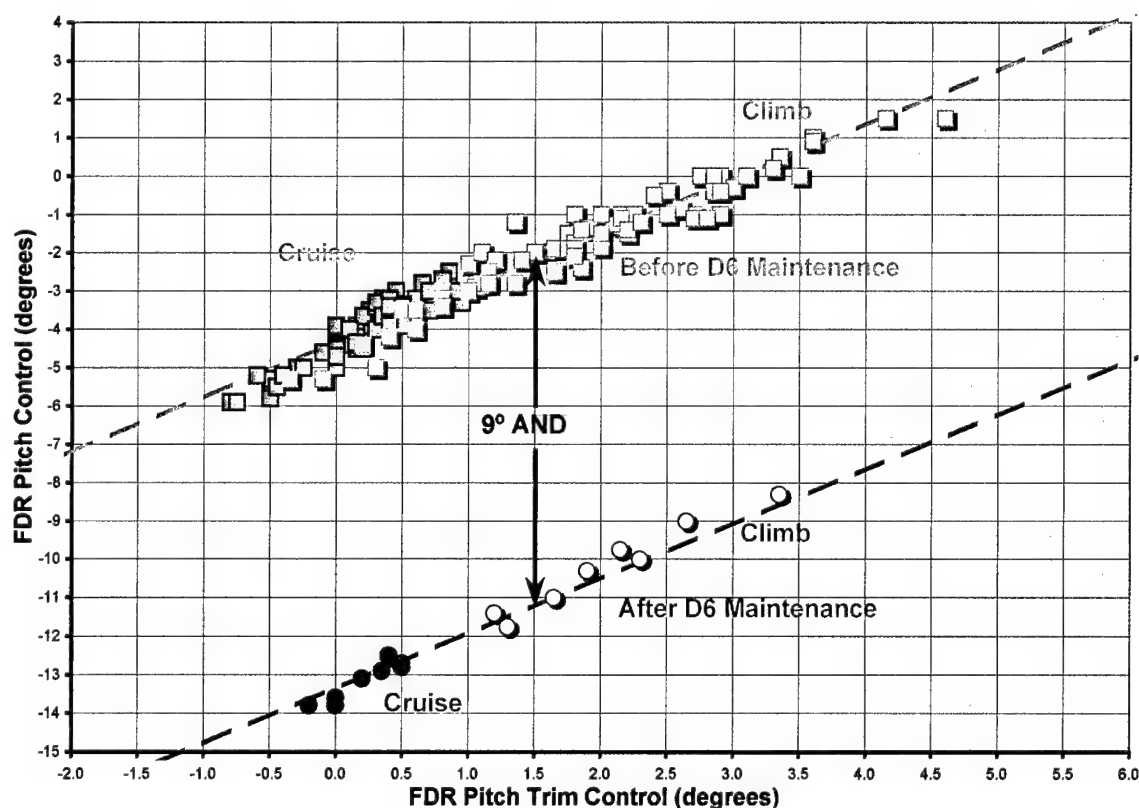
The position of the trim tab is the predominant predictor of elevator position during climb and cruise flight. Figure 8 shows that a strong correlation exists between elevator (FDR pitch control position) and trim tab (FDR pitch trim control) data. The figure shows two distinct data groups: the larger group represents flights before the D6 maintenance check, and the smaller group represents flights after the D6 maintenance check.

**Figure 8.** Flight data recorder pitch control and pitch trim control positions.

The larger group of data shown in figure 8 (that is, the flights before D6 maintenance) compared well with the Beech 1900D flight test certification data, indicating that the premaintenance FDR pitch control position data represented the actual elevator position to within about 1°. However, the smaller group of data (that is, the flights

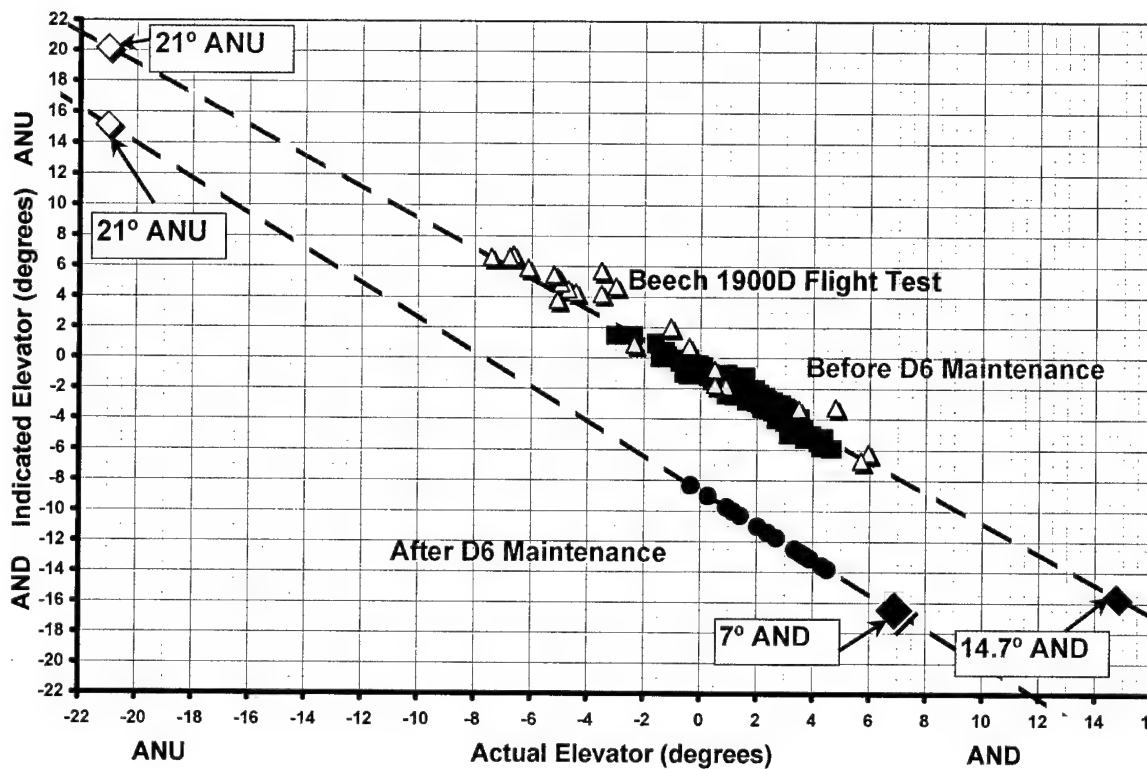
**Figure 9.** Elevator travel available before and after the detail six maintenance check.

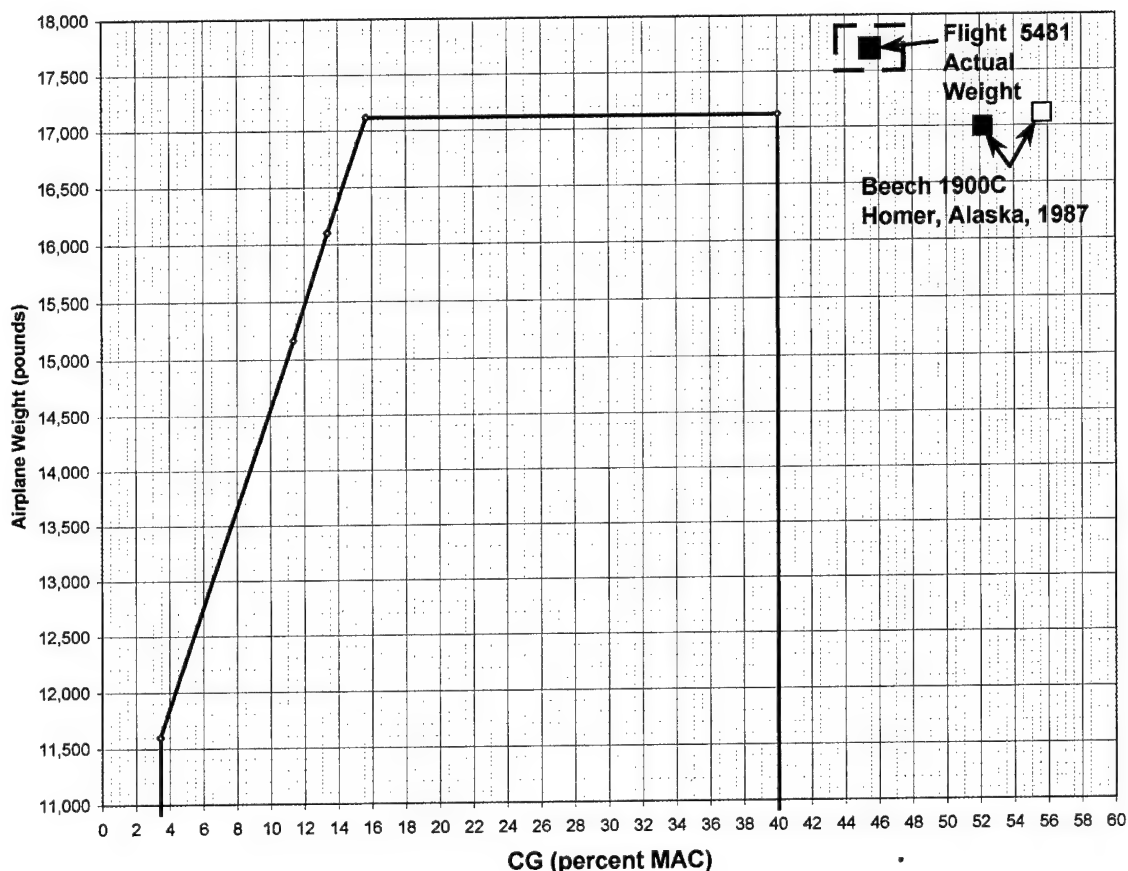
Figure 11 shows flight 5481's weight and CG information compared with that for the flight 103 accident airplane. Two data points in the figure show the CG range for the flight 103 airplane.

**Figure 11.** Flight 5481 weight and center of gravity information compared with flight 103 weight and center of gravity information.
